# Rexroth IndraDrive MPx02, MPx03, MPx04, MPx05 and HMV

## Troubleshooting Guide

**Purpose of Documentation** This documentation contains the descriptions of all diagnostic messages implemented in the firmware for drive controllers and supply units of the IndraDrive range.  
It assists machine operators and installation programmers with trouble shooting.

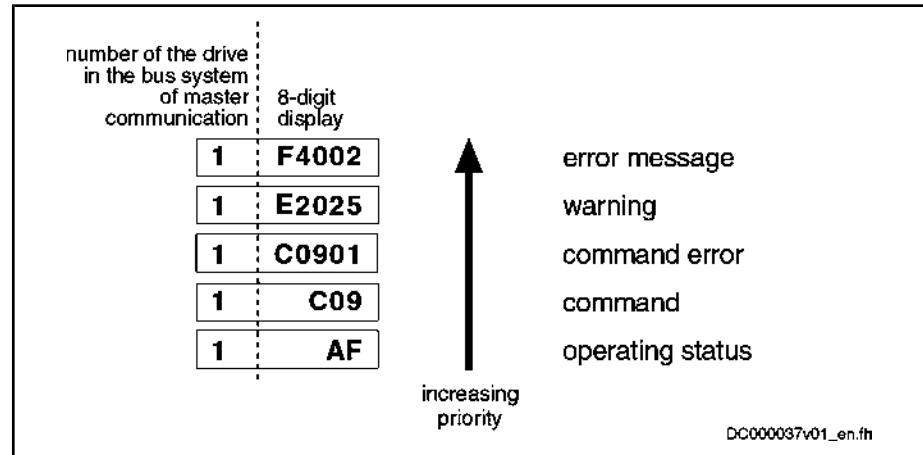
Fig.4-1: Priorities of displays (with example displays)

The following priorities apply for displaying the current diagnostic message:

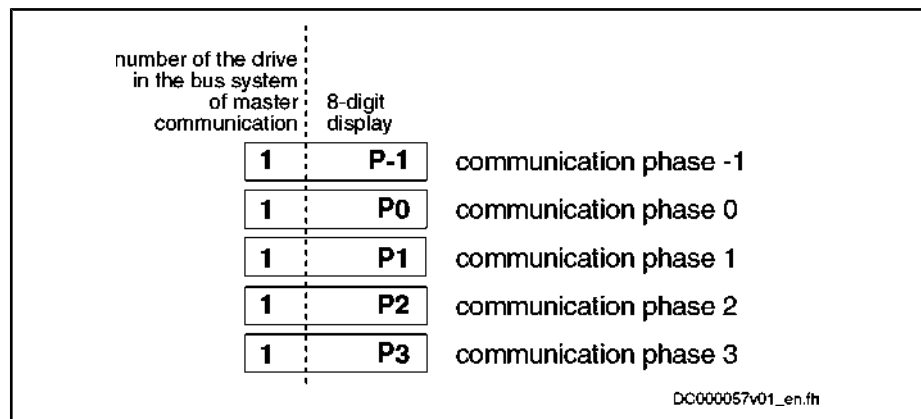
Fig.4-8: Displays during phase progression of the master communication

- Status of the master communication
- Operating status
- Activated commands and command diagnoses
- Warnings and diagnostic error messages

The displays have priorities because it is impossible to have various displays at the same time.

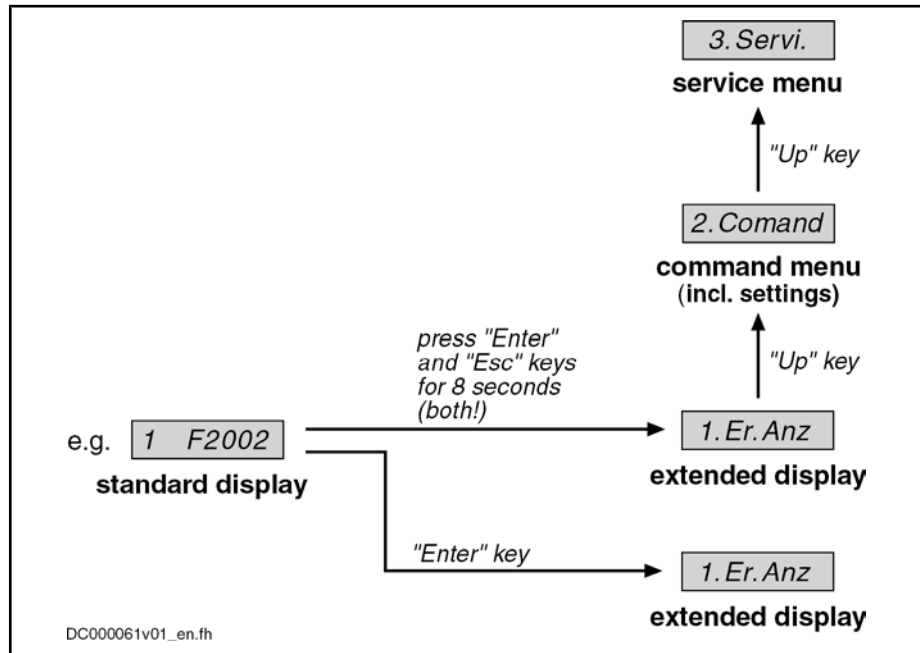
Fig.4-13: Activating the extended display, the command menu and the service menu

The extended Display can always (without interlock release) be accessed by pressing the "Enter" key.

By simultaneously pressing the "Enter" and "Esc" keys (for 8 s) in the standard display, the command and the service menu can be called up in addition to the extended display.

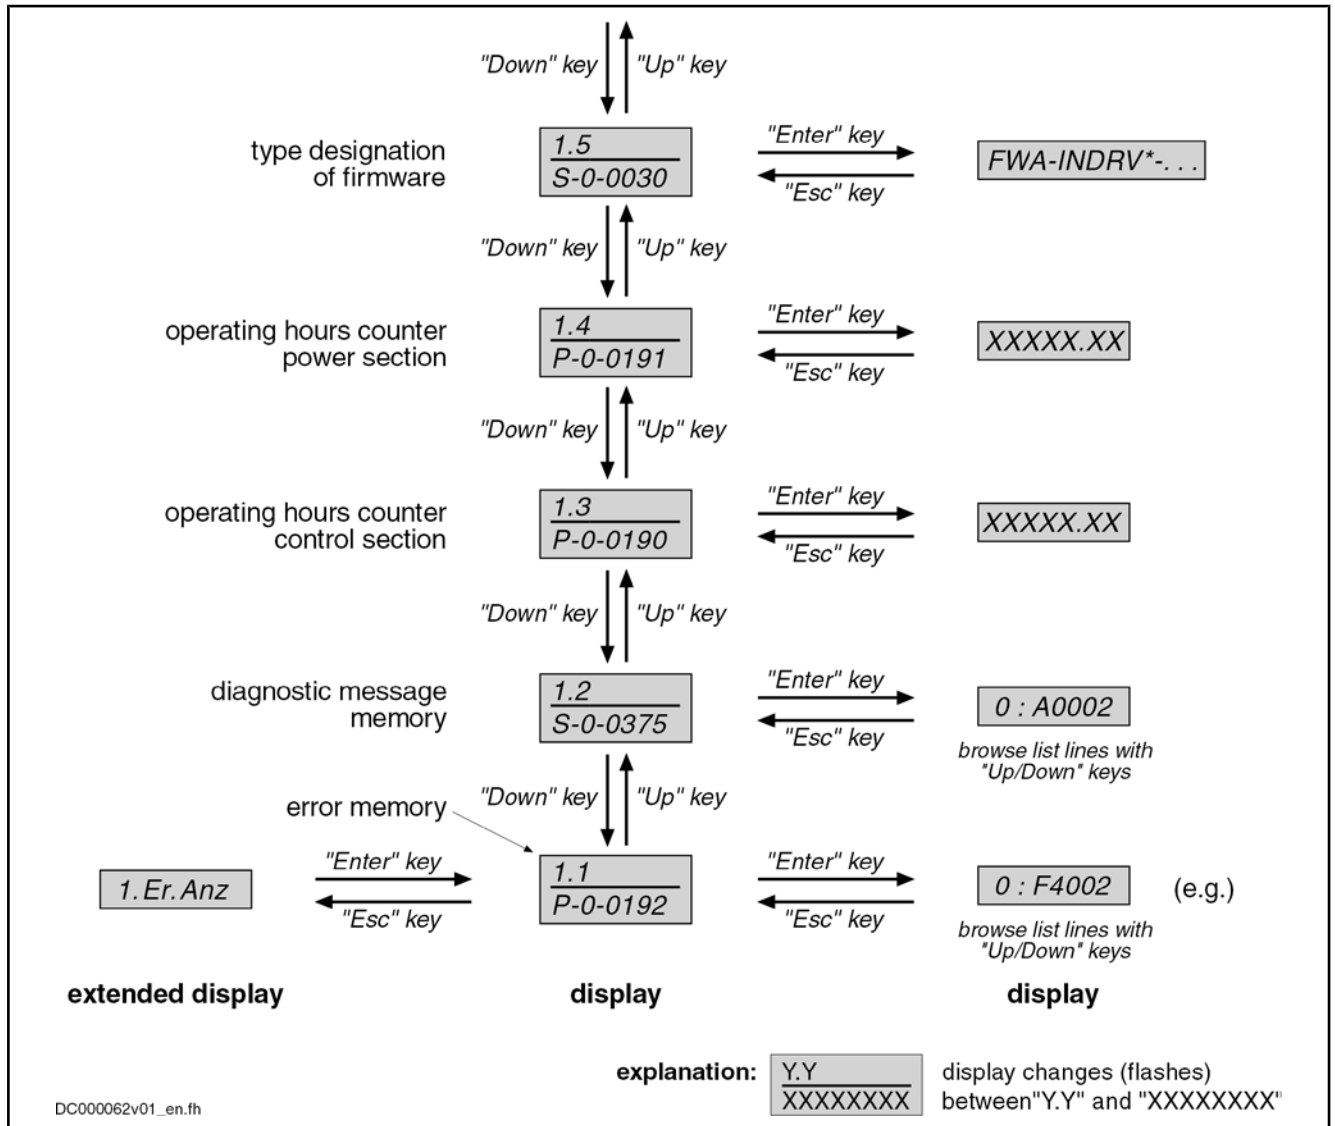
Fig.4-14: Activating the extended display

- Safety technology code, change counter of safety technology and operating hours counter since last change (if safety technology option available)
- MAC address (when using CCD option, SERCOS III master communication or control section CSH01.2)
- Diagnostic field bus message (P-0-4073)
- Active memory

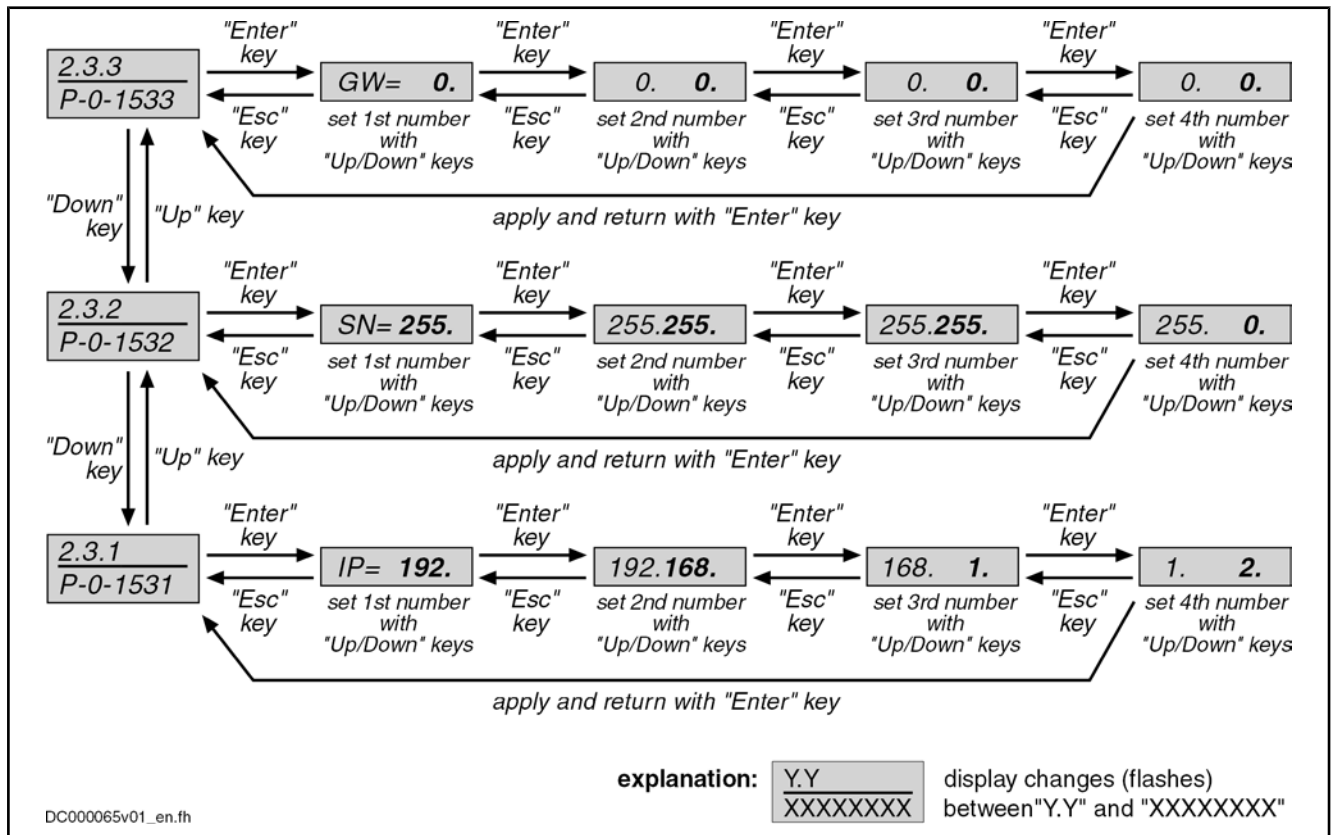
Fig.4-17: Setting the Ethernet communication, as an example of the control section Engineering Port

The settings can be made via the standard control panel and are basically the same for all Ethernet-based interfaces.

GW gateway address, e.g. 0. 0. 0. 0  
 SN subnet mask, e.g. 255.255.255. 0  
 IP IP address, e.g. 192.168. 1. 2

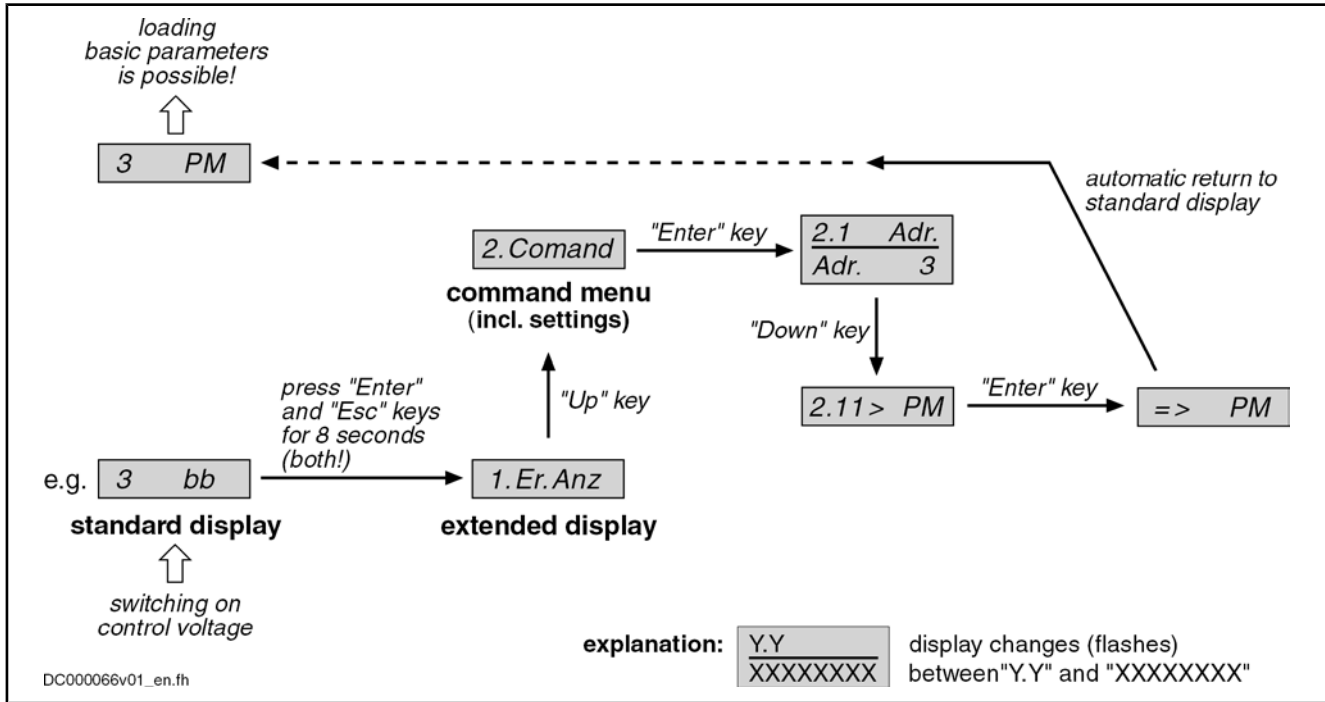
Fig. 4-18: Activating the parameter mode via the control panel

In order to carry out "C07\_1 Load defaults procedure com. (load basic parameters)", the parameter mode (PM) has to be activated.
